**RE: Approval of Fusion Plast Electro Fusion Fittings**

**TECHNICAL SERVICES  
TEST REPORT**

**Subject:** Approval Testing of Fusematic PE100 125mm x 32mm saddle and two Fusematic PE 100 125mm caps

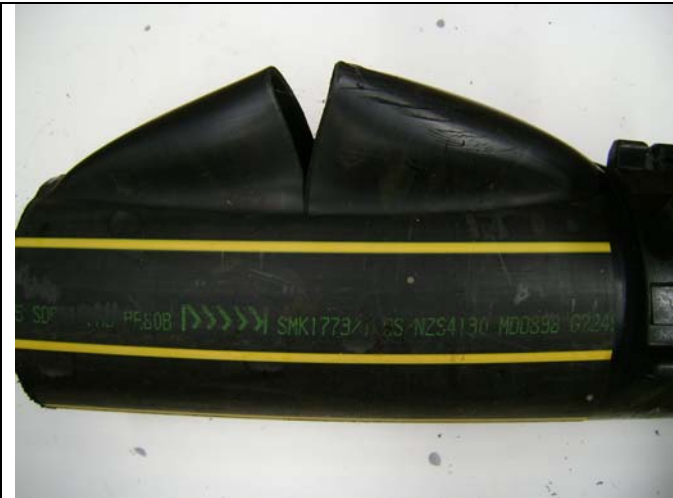
Fig. 1 Burst PE 80B pipe

The test continued for 134 hours instead of 165 hours required because the pipe burst. During this 134 hours period, the assembly remained leak-tight. The pipe (PE80B) failure was found to be due to application of excessive hoop stress. The PE80B used for testing was found to have been manufactured at the lower extremity of wall thickness of 10 mm, which must have also contributed to the failure of the pipe. Based on an internal pressure of 1104 kPa and wall thickness of 10 mm pipe, the hoop stress applied to the assembly became 6.3 MPa instead of 4.5 MPa (equivalent to an internal pressure of 900 kPa).

The Fusematic PE100 samples submitted for leak-tight testing were satisfactory for the duration of the testing, which had to be terminated at 134 hour because of the PE80B pipe burst. The failure was due to excessive hoop stress applied to the pipe.

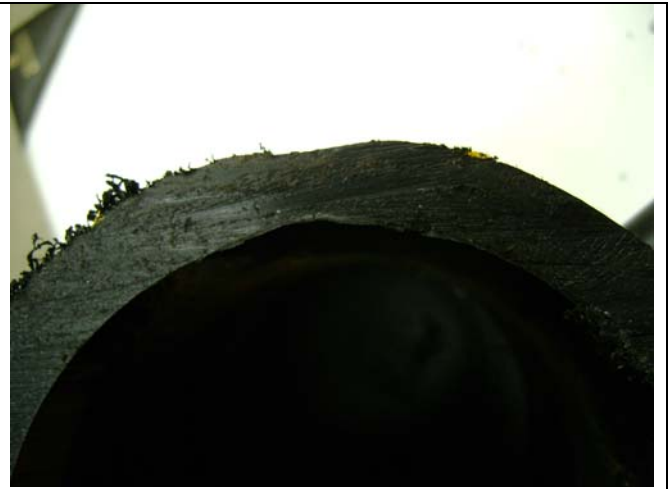
Fig.2 Thin wall thickness of PE 80B approx. 10 mm

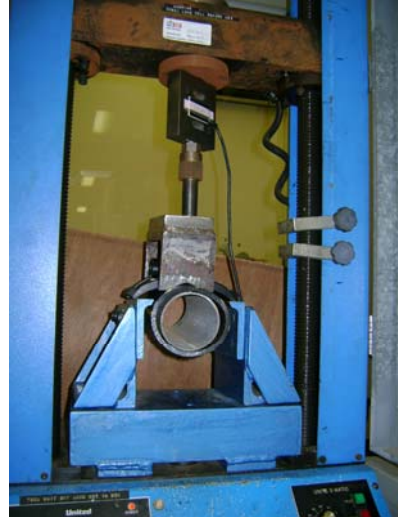
Fig.4 Compression method of testing the saddle/pipe joint sample

Decohesion Tear test (ISO/DIS 15956): The saddle is bodily torn off the pipe, and the extent of failure mode of separation noted. (The saddle is supported in the plane of its clamping flanges on each side of the pipe in a jig mounted in a tensile testing machine, and a compressive force is applied to a close-fitting mandrel passing through the pipe, the compression cross head speed was 30 mm/min, see Fig 4.)

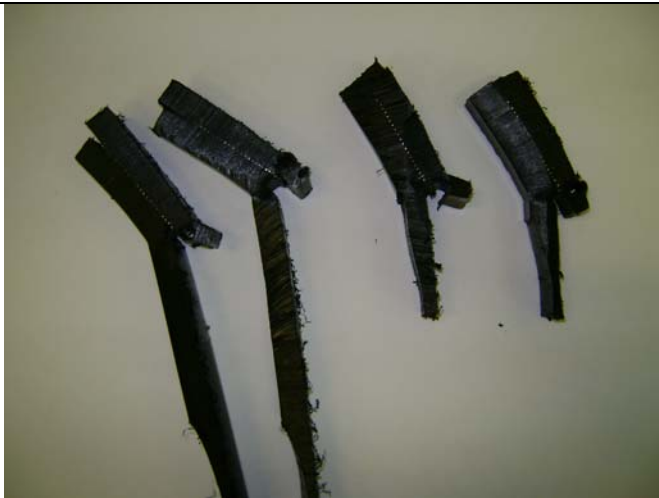
Fig. 5 Fusematic cap/pipe joints failed in ductile mode

Fusion integrity test on the saddle electrofusion weld and on both caps electrofusion welds were found to be satisfactory, indicating failure in the ductile mode. The bond did not separate as the pipe had yielded before separation occurred.

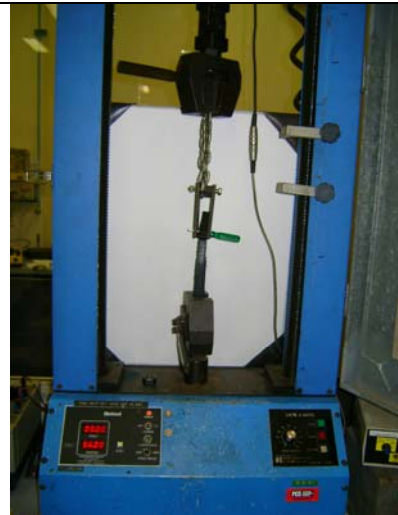
Fig.6 Tensile method of testing the cap/pipe joint samples

In the Decohesion Tear test of cap/socket (ISO13954), the socket/cap is torn off the pipe, and the extent of brittle mode of separation noted. (The socket/cap is horizontally clamped in a jig mounted vice in a tensile testing machine, the end of the pipe is inserted in the tensile tester. A tensile load along the longitudinal axis of the test piece at a speed of 25 mm/min is applied until complete separation or pipe yields.)
